**Cockle Cove and Bucks Creek Salt Marsh System
Site Assessment Report**

Association to Preserve Cape Cod
October 2021

Contracted by the CCF Salt Marsh Task Force: Gerry Stahl, Chair

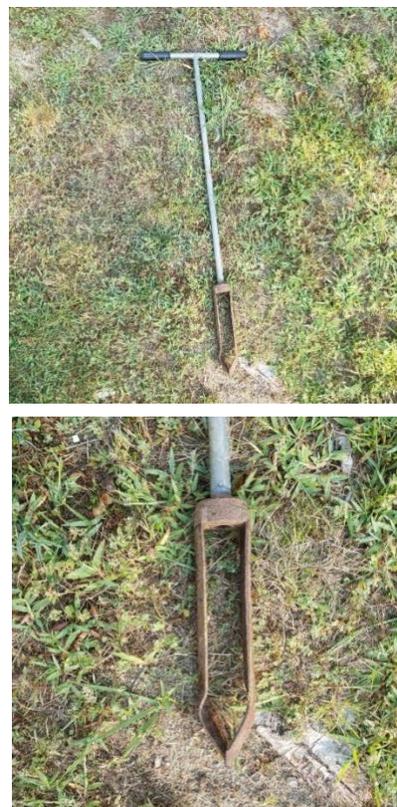
Figure 3: Photos of the auger used to collect soil samples.

Soil samples were collected on July 20th, 2021, using a metal hand auger (see Figure 3). The auger had a 1-foot boring spade. All samples were pulled by turning the hand auger in a clockwise circle while applying pressure to the handles until the top of the spade was level with the soil surface. The hand auger was then pushed back and forth to help loosen any attached roots or soil to get a better sample.

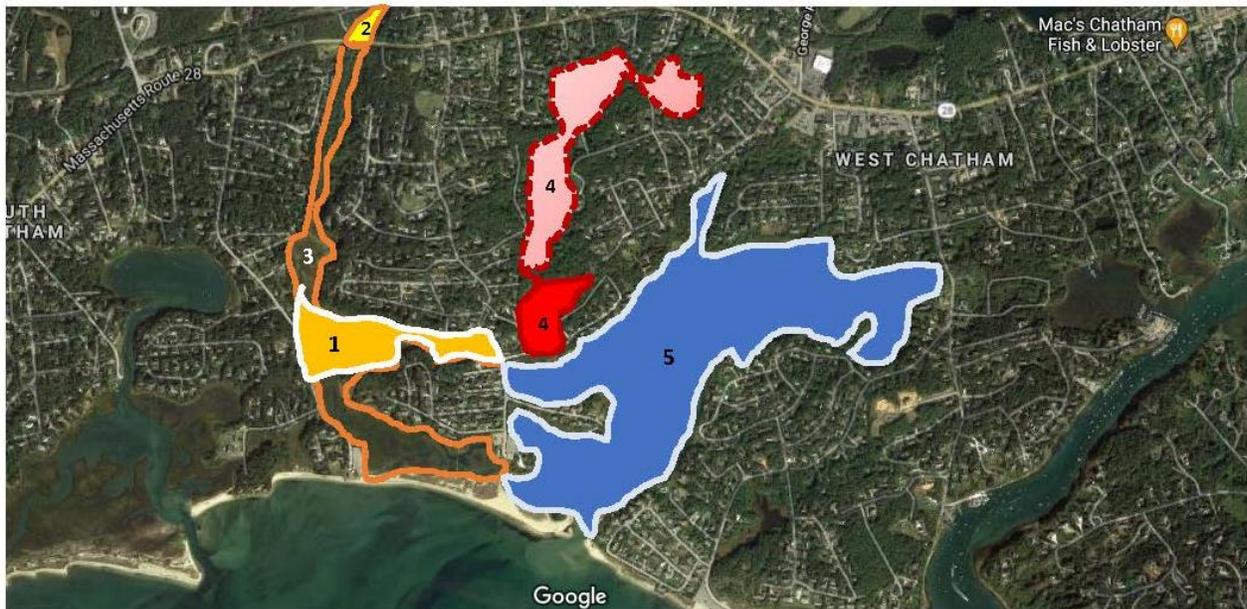
Figure 4: This map depicts the five subsections of Cockle Cove-Bucks Creek marsh system used for the GIS-based desktop assessment and restoration ranking. The five subsections are as follows: 1) Ridgevale Road restriction west to Cockle Cove Drive, 2) Cockle Creek north of Route 28, 3) Cockle Cove Creek and marshes west of Ridgevale Road, 4) Bucks Creek north of Cranberry Lane (dashed line indicates area of Star Bog and active cranberry farming), and 5) Bucks Creek (and Sulphur Springs).

All five subareas of Cockle Cove and Bucks Creek (Figure 4) ranked moderate to high (>35pts) according to APCC's 11 criteria with the highest score for the eastern Bucks Creek marsh and entire Cockle Cove Creek marsh (Table 2). These high scores relative to scores for other potential restoration projects and sites ranked by APCC across Cape Cod indicate the high value of this marsh complex and support the need to protect, preserve and restore this area. This high score is largely driven by the high scores received due to potential to improve impaired waters (bacteria or nutrient impairment) through restoration, the large area(s) of the marsh, overlap with sensitive resources along the coast (Biomap Core habitat, NHESP priority species habitat, and shellfish habitat), protection of the area by the town and Chatham Conservation Foundation ensuring long-term preservation of the marsh, resilience to sea level rise and erosion, and local support and interest from the Foundation to protect, preserve and restore this marsh complex.

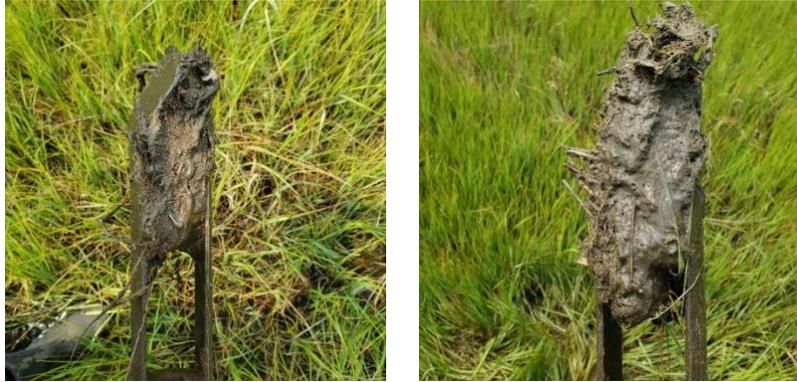
Figure 13: Images of Cranberry Lane reference marsh soil samples (left to right): Sample RIW-60 and sample R3S-120. No image was taken of R4NE-60.

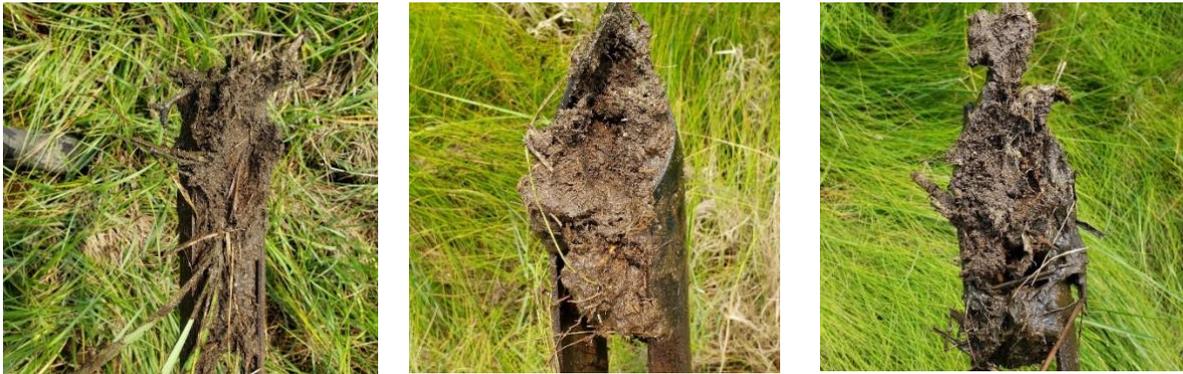
Figure 14: Images of Cranberry Lane restored study marsh soil (left to right, top row to bottom row): samples S1E-15, S2E-60, S2W-60, S3W-60. No images shown for S3W-120 and S3E.

It was noticeable easier to get the auger into the study marsh side north of Cranberry Lane indicating that the peat layer is less compact or developed. There was more sand and mud under a layer of marsh peat.

The samples taken in the restored area of marsh were largely composed of peat, mud, and sand (Figure 14). The marsh west of Ridgevale Road was very unstable to walk on indicating a less developed peat subsurface. Sample collection was attempted at the central part of the small marsh surrounded by *Phragmites*. However, due to the small layer of peat floating on an unstable, watery substrate, soil extraction was not possible.

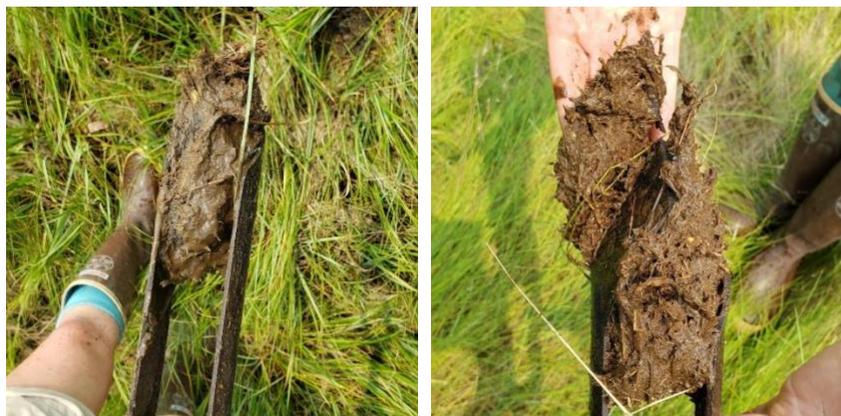
Figure 15: Images of Cackle Cove Creek marsh south of Pine Knoll (left to right): sample from western edge of cackle cove, and sample from east near data logger deployment location.

The Cackle Cove Creek salt marsh south of Pine Knoll Road was firm to walk on with a very well-developed peat layer. Samples taken both at the western edge of the marsh and the eastern section near the location of the water level logger deployment were both composed of 100% peat indicative of a healthy marsh soil (Figure 15). The soil sample taken in Bucks Creek marsh west of Barn Hill Road was also composed of 100% peat (Figure 16).

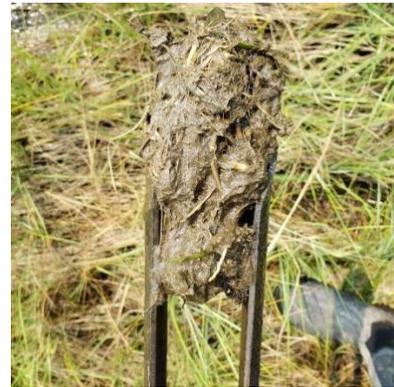
Figure 16: Image of soil sample taken in Bucks Creek reference marsh west of Barn Hill Road.

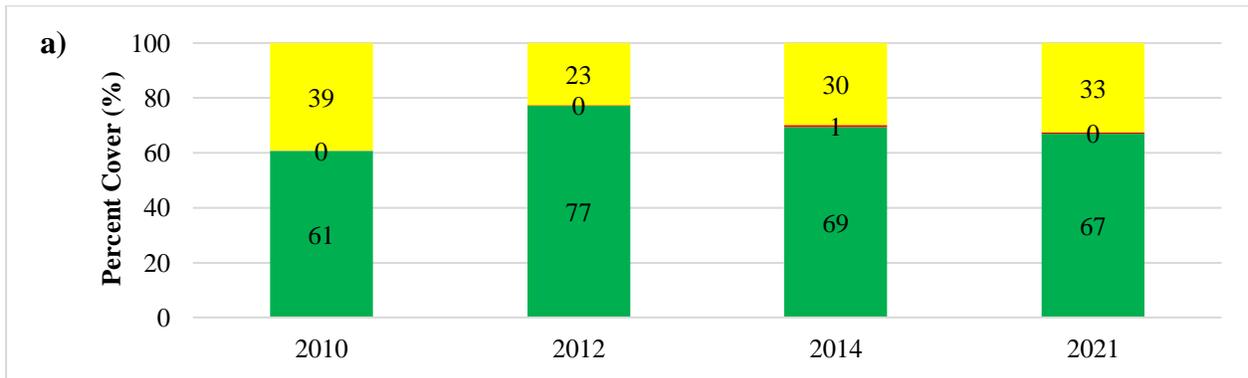
Figure 17: Results from the vegetation quadrat survey in the a) reference and b) restored area of the Bucks Creek marsh (south and north of Cranberry Lane, respectively). The culvert restriction was removed in 2011.

The data from the 2012 transect-quadrant monitoring show the vegetation following an early response to the restoration as predicted, but subsequent years of monitoring show the restored area reverting back to the vegetation composition seen before restoration (Figure 17). Interestingly, the reference marsh also shows a similar increase in halophytes (namely *Spartina alterniflora*) in 2012 which suggests that other environmental factors (e.g., precipitation) may be the primary driver influencing these changes. In the restored marsh, the *Phragmites* cover remains largely unchanged, and the halophytes continue to be outcompeted. Additionally, the average height of the *Phragmites* increases over time following the restoration with the tallest stem heights in 2021 (Figure 18). Since the tidal flow restoration does not appear to have impacted the percent cover or growth pattern of *Phragmites*, there must be other factors influencing its survival. Possible explanations for the resistance of *Phragmites* concern the depth of the groundwater table and leaching of nutrients. *Phragmites* has been known to have extensive rhizomes (or root systems) which allows it to reach deep into the groundwater table for freshwater and nutrients.
